Transportation Safety Board
of Canada

TRANSPORTATION SAFETY

REFLEXIONS

Issue 22 – July 2005

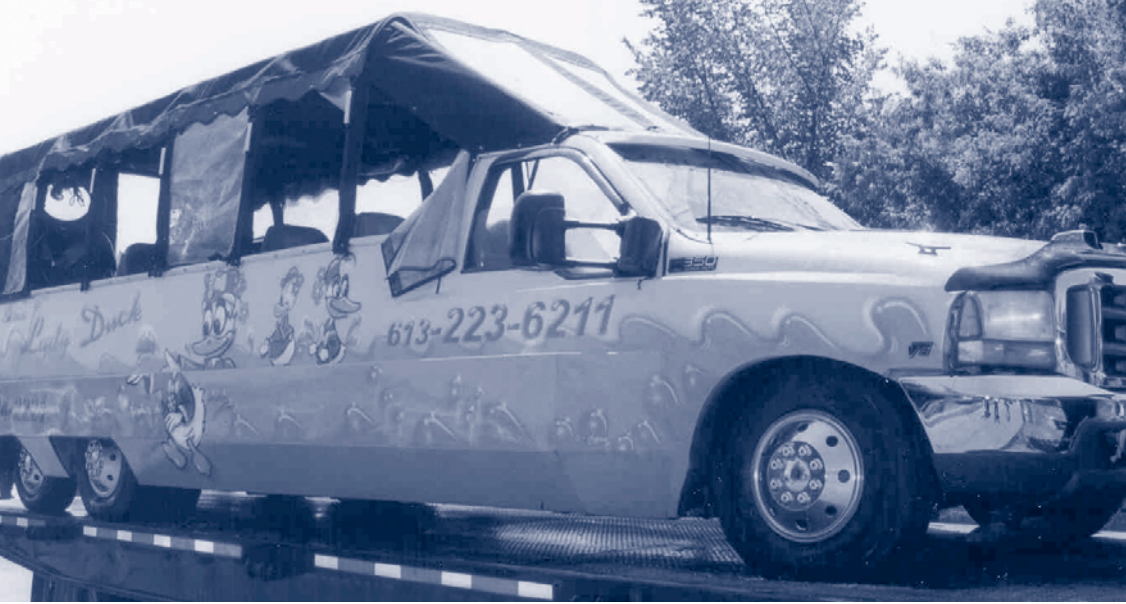
Lady Duck after recovery at the Hull Marina

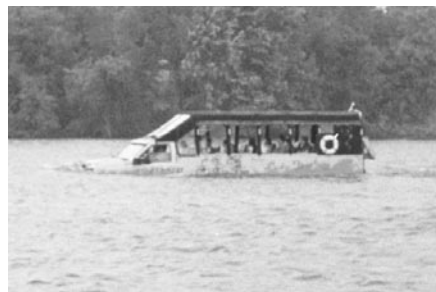
Lady Duck approximately five minutes before sinking. Reproduced with permission.

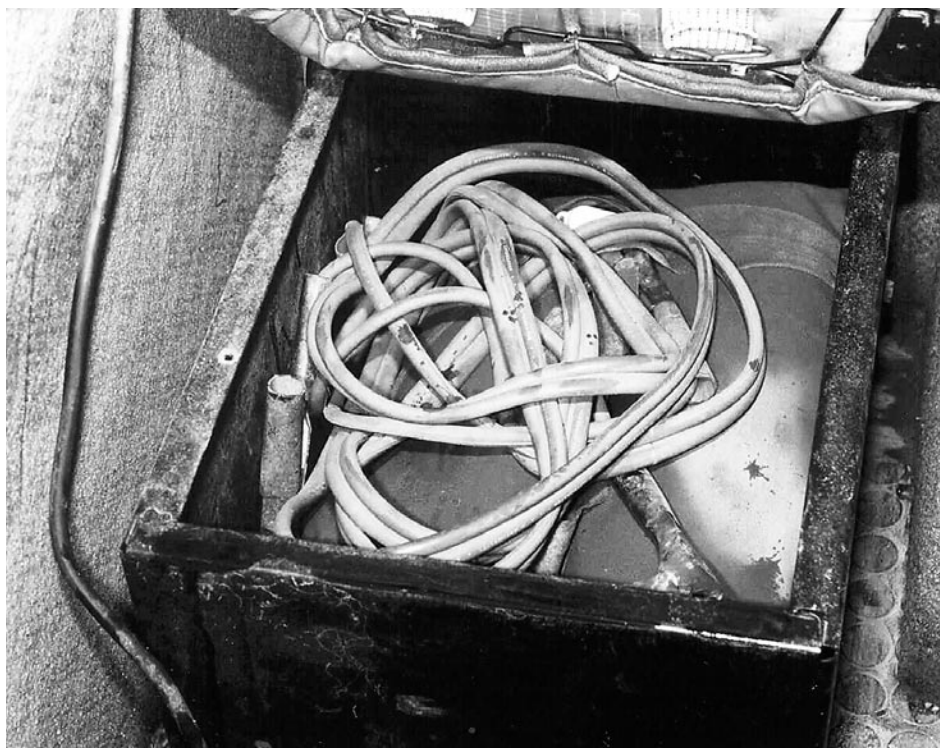
In order for the passengers to retrieve the lifejackets from their storage location beneath each passenger seat, it would have caused congestion in the narrow centre aisle. During vehicle inspection after the occurrence, removing a lifejacket without tearing it on the edges of the metal storage box was a challenge for investigators, let alone passengers who, in a time-critical situation, could have jeopardized the integrity of the jacket. Further, other items that were stored on top of the lifejackets would have presented a challenge to their quick removal.

Lifejacket under the seat with booster cables on top

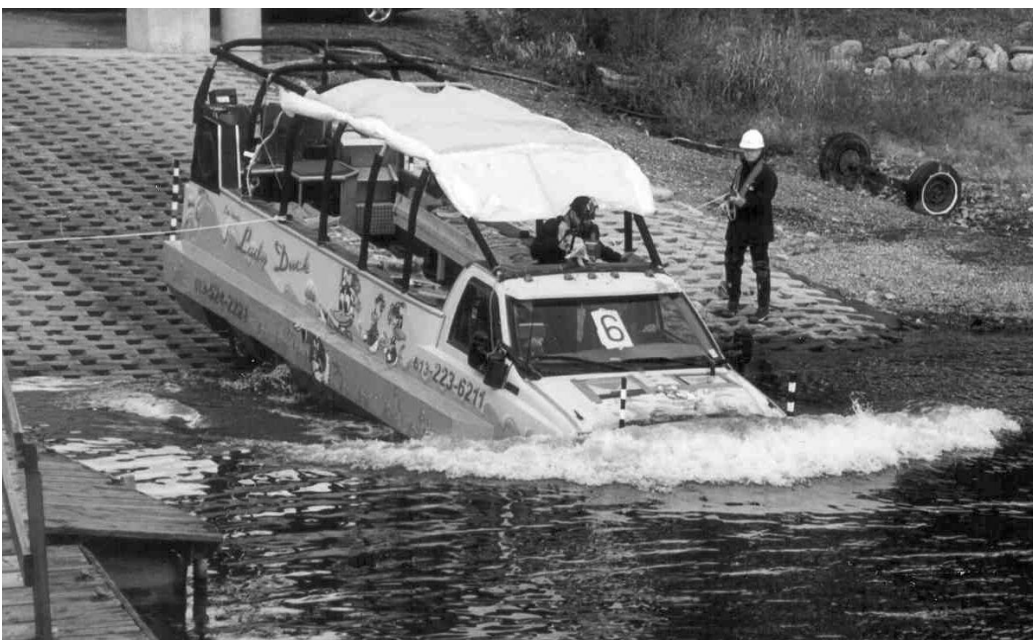
- When operating in calm water conditions, the *Lady Duck* was vulnerable to shipping water over the bow, because of low initial static forward freeboard and of proportional loss of effective forward freeboard due to the bow wave created by the speed of the vehicle.
- When operating in water disturbed by the wakes of other craft, the *Lady Duck* was highly vulnerable to shipping water when relatively moderate waves were encountered.
- The effective static forward freeboard in the loaded condition, when reduced by the progressive accumulation of floodwater in the hull, was insufficient to prevent the entry of water from bow waves generated at service speed.

Vehicle launched at 8 km/h, visor submerged by approximately 25 mm

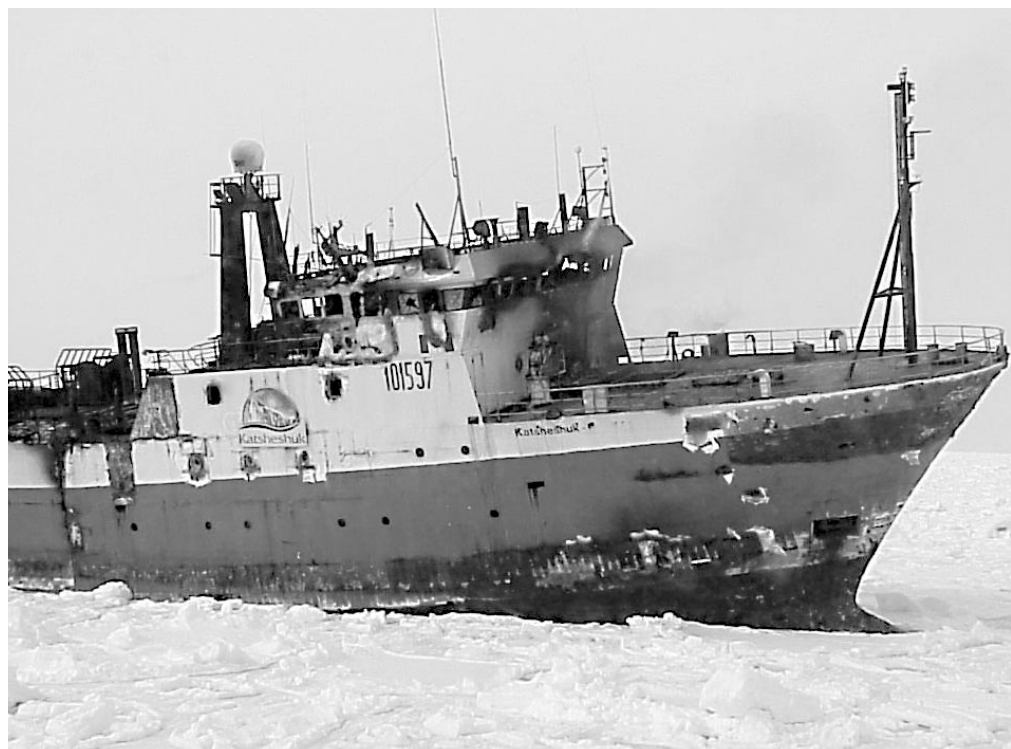
Post fire

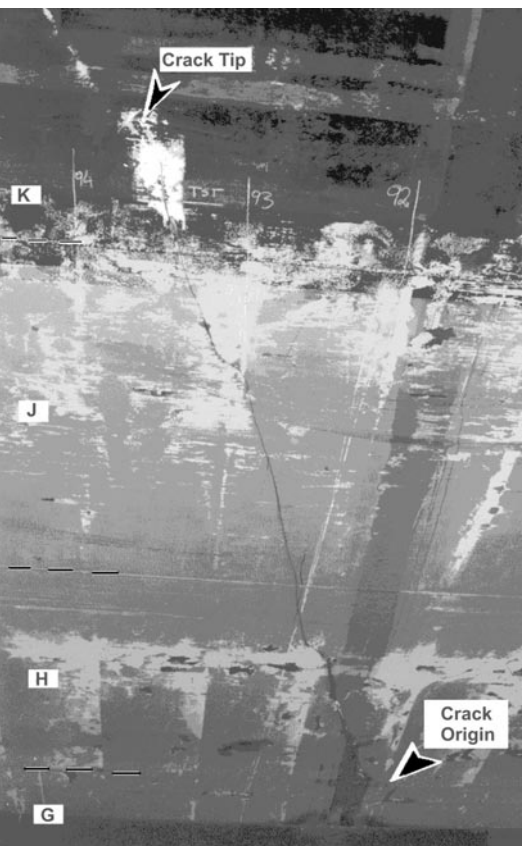
The principal fracture was on the port side frame at frame 91, extending upwards and forward from the toe of the weld at the base of the side shell frame. The fracture traversed frames 92 and 93 through the H and J strakes, terminating just short of frame

94 (K strake) in the No. 4 upper water ballast tank, which was empty at the time. The shell fracture divided at the juncture of the ballast tank sloping plate: one branch continuing for 45 cm on the ballast tank sloping plate at approximately 90° from the juncture point, and the other branch on the ship's side continuing up and forward for approximately 40 cm past the juncture point. Visual inspection and laboratory analysis indicates that the principal fracture originated at the base of frame 91 (at the toe of the weld). The fracture origin was located 1.3 m below the neutral axis of the vessel's midships section modulus.

Principal fracture

The extremely low fracture toughness of the side shell plate when exposed to temperatures near 0°C allowed the forward crack at frame 91 (port) to grow to failure at a load well below the ultimate tensile strength of the material.

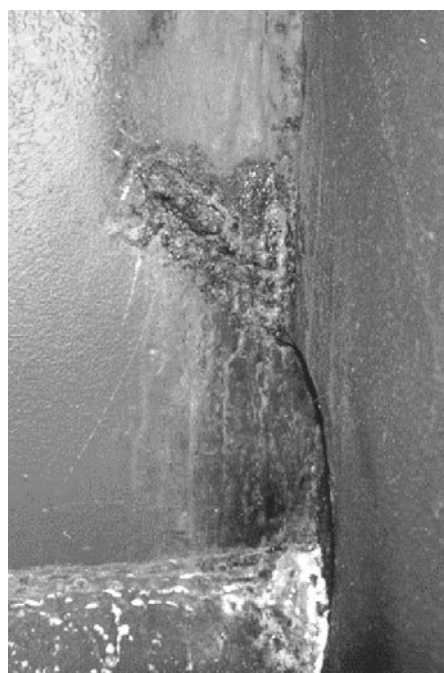
In the No. 2 hold, four crack locations were also found: on the starboard side at frames 171^{1/2} and 172^{1/2}, and on the port side at frames 144 and 145. In contrast to the cracks in No. 4 hold, all the cracks in No. 2 hold had been covered with superficial weld repairs. The weld repairs had penetrated only a few millimetres into the thickness of the hull plate. It was not determined when, or by whom, these repairs were undertaken, nor is there any record held by DNV of these cracks or the repairs. In contrast to the crack manifestations in No. 4 hold, not all these cracks were present both fore and aft of the frame, such as at frame 171^{1/2}, where the crack was only forward of the frame.

Frame 171^{1/2}, starboard

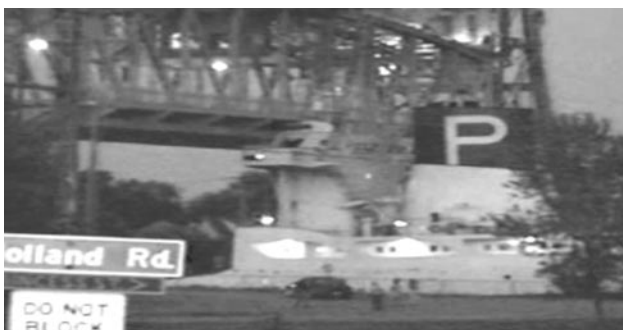
Bridge 11 striking vessel in way of wheelhouse front windows. Reproduced with permission.

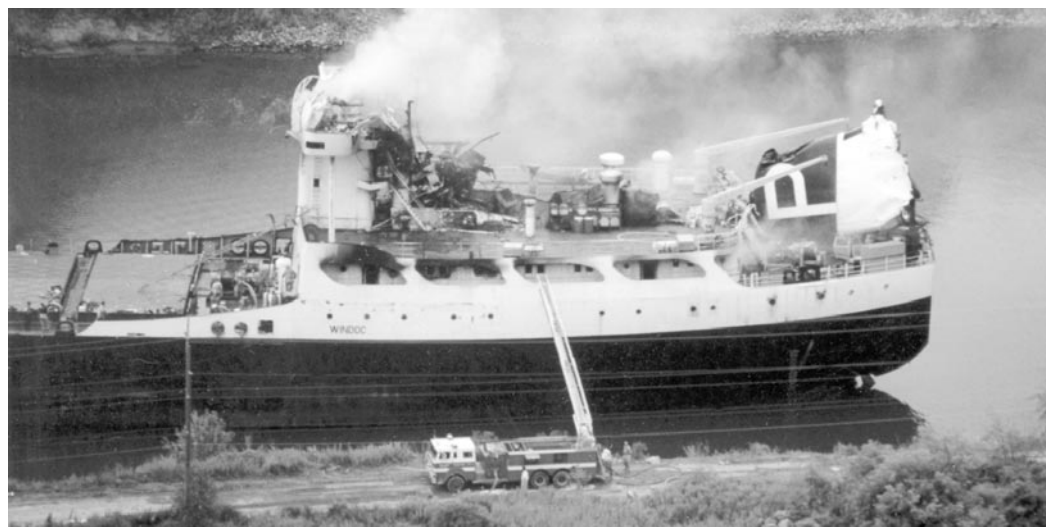
Aerial view of aft section of vessel with fire department vehicle on site (photograph by Harry Rosettani)

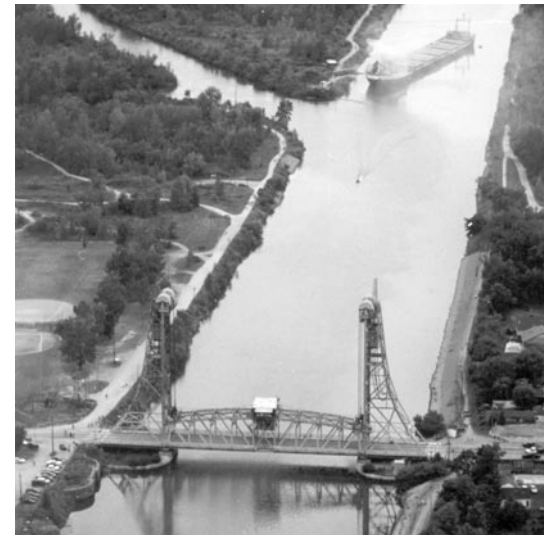
Aerial view looking north at the bridge and vessel after the striking (photograph by Harry Rosettani)
